**NOTICE IS HEREBY GIVEN** that a special meeting of the Village Board of the Village of Neosho shall be held on **Thursday, November 16, 2023**, 6:30 p.m., at the Neosho Village Hall, 210 S. Schuyler Street, Neosho WI.

Re: Assessment of Recommended or Required Actions  
Neosho Dam, Rubicon River

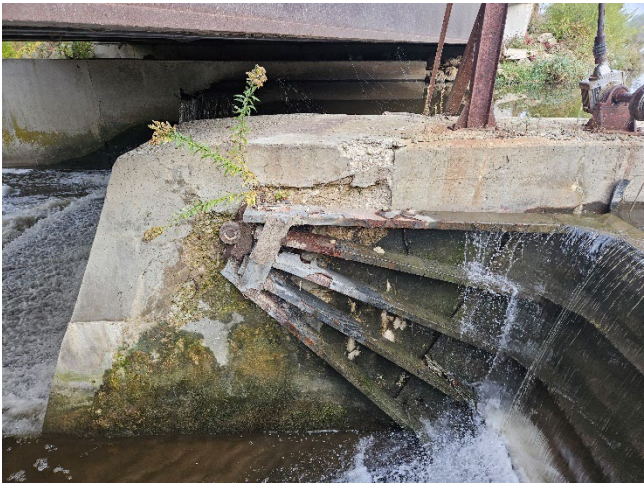
**Critical Item:** Structural Deficiencies Evident in Gate Supporting Concrete. The inspection revealed key structural deficiencies in the supporting concrete at the trunnion. See below pictures:

*North Trunnion Condition, Delamination & Structural Deficiencies*

The conditions shown above are of a nature that, when combined with the vibrations and continued advanced state of concrete disrepair, conditions will advance rapidly and place the structure in a watch condition. For example, the cracking shown above

does not appear and is not mentioned in the prior 2021 inspection report. In just 2 years, we have seen substantial deterioration. This is a certainty to continue, but at more advanced rates due to the delamination of the concrete surface even if the vibration addressed.

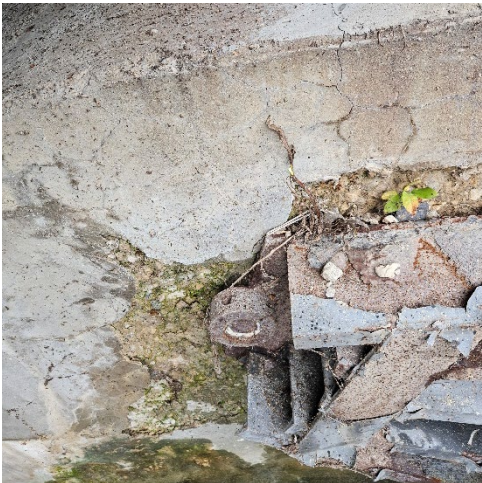
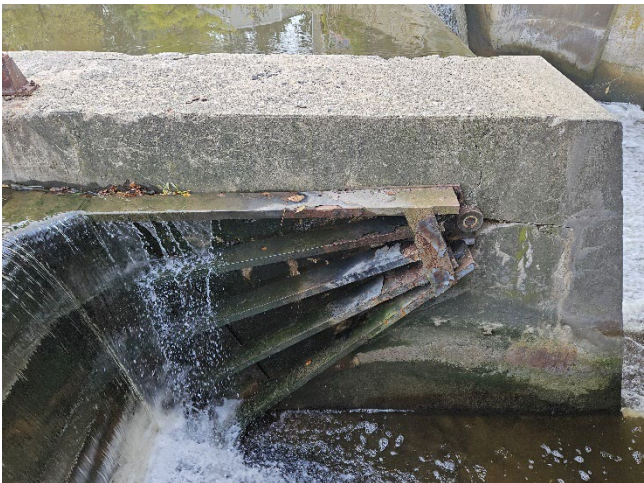
*South Trunnion and Structural Deficiencies*

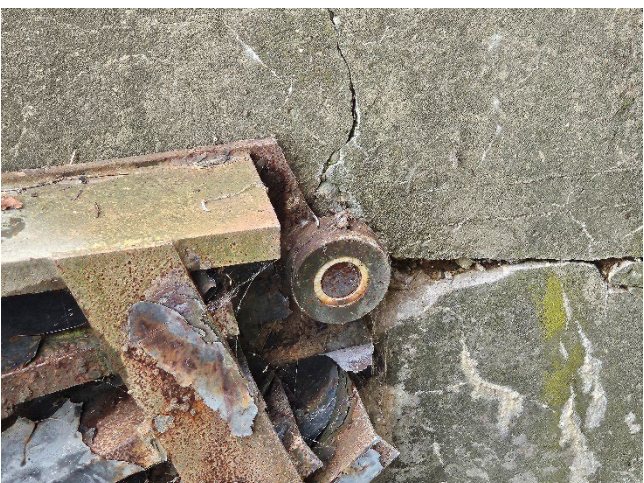
*South Trunnion Structural / Radial Cracking*

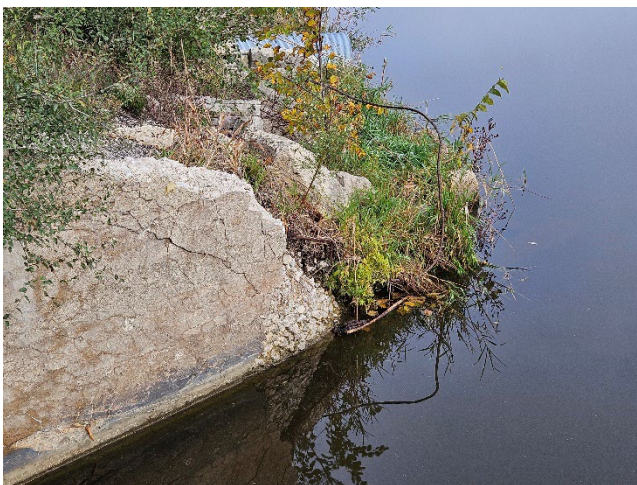
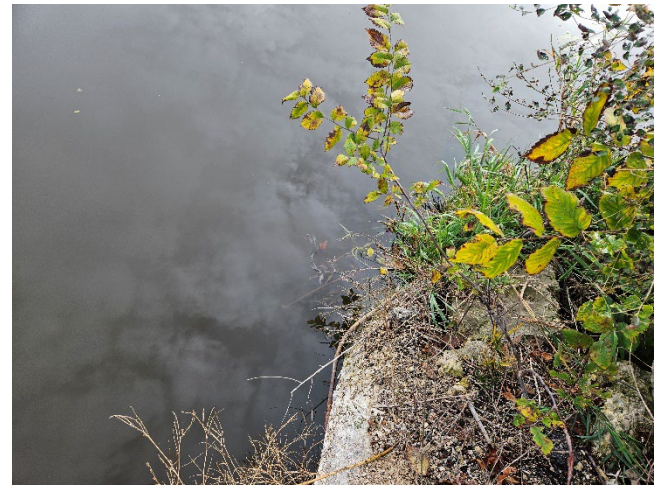
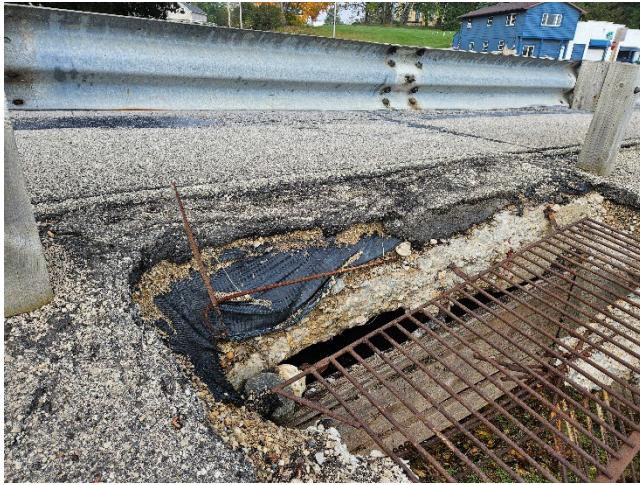
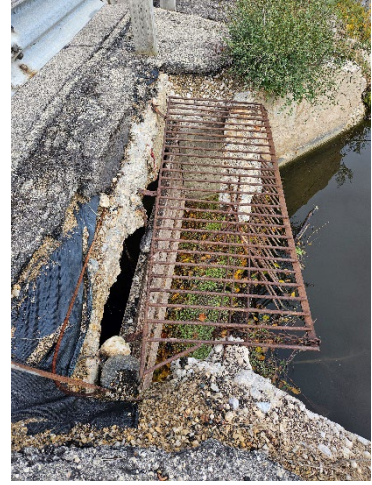
**Item:** Bypass Stop Log & Inlet Condition. Although not integral to the main dam components, the bypass may function to lower water level and to provide secondary outlet flow. However, the inlet area of the stoplog system is substantially deteriorated. See below photos:

The stop logs are significantly bowed and the entrance concrete is deteriorated, possibly beyond repair. There are many areas of exposed rebar wherever there is an exposed concrete surface. From a visual inspection, the extent of the repair is limited to the inlet area, but the condition is advancing to become a structural roadway issue. A loss of the stoplog system would likely drain the lake at least in part.

**Actions:** The assessment and scope of work identified herein are recommended with priority importance. Short-term modifications to the radial gate, perhaps in only operations/settings, are recommended to occur as immediate as possible given all rules and regulations including notifications, if required. Gate refurbishment and concrete repair/replacement are the major work-scope items for the main dam and possibly the bypass facility. All modifications need to be done in accordance with the appropriate rules and regulations, and we also add the caveat that all capital improvements should be completed in accordance with possible WDNR Municipal Dam Grant Funding should that funding and this potential application be considered. Timing on grant matters is also of immediate importance if the work is to be funded in this biennium (March 2024 application deadline). Given the outstanding condition of the DFA (dam failure analysis) for this dam, it is also recommended that this item be completed along the earliest allowable timeframe as it will be a key feature of any dam improvement plan.
