Neosho Dam Repair Project

Dam Inspection Memo - September 14, 2021

RE: Inspection Report for Neosho Dam, FF # 14.14 Seq 1077

Village of Neosho, Dodge Co
Neosho Dam Inspection Photo Log

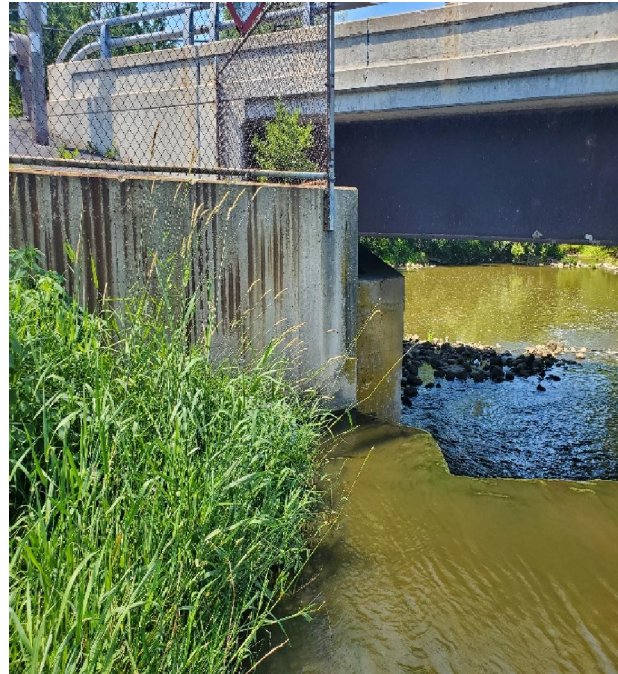
0107707122022 4

In 1994 the spillway was repaved, pressure grouted, and the steel tainter gate replaced. This inspection shows cracks and spalling have developed on the downstream side of the gate wings. The most serious being a section of the 94 repair on the south wing that is washed away in the splash zone exposing reinforcing steel. This situation currently does not appear to be structurally significant, but must be monitored. As indicated in the 2011 Inspection Report, the steel tainter gate needs to be recoated to prevent further corrosion.

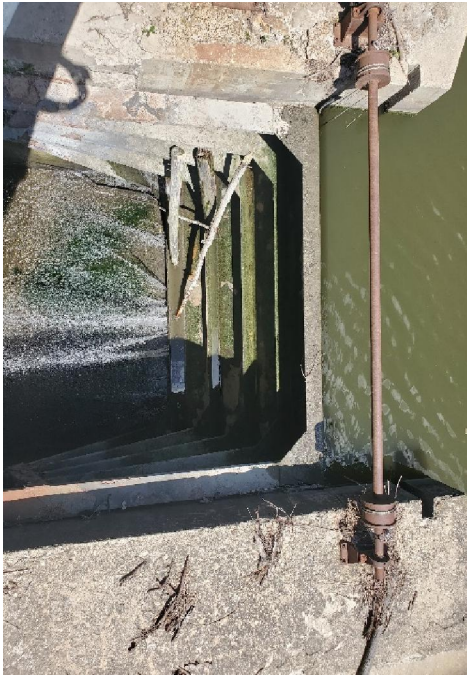
0107707122022 6

SPILLWAY-PRINCIPAL - GATES				Action		
Item	N	P	Notes/ Observations	M	I	R
1 Gates	<input checked="" type="checkbox"/>		No problem			
A. Types (lift/slide, tainter(radial), stoplogs, leaf, roller, flashboards, needles, other): Number and Size:	<input checked="" type="checkbox"/>		TAINTER CORROSION ON GATE 1

F. Access			BRIDGE DECK FROM STH 67			
G. Condition Rust: Seals (leakage):	<input checked="" type="checkbox"/>		GATE IS RUSTING IN SPOTS			
H. Ice protection Type (Heaters, Bubblers, Barriers, Other)			N/A

Gate Recoating Maintenance is required as outlined below, with a target completion of September 30, 2025:

- install temporary dam / dewatering provisions and remove gate
- provide nearby temporary containment for blasting and coating or transport gate to shop.
- sandblast gate and struts, preparing steel surfaces to "near-white blast level"
- apply zinc primer coat, stripe coat, 2nd primer and finish epoxy coat or equal
- inspect and repair/replace gate seals as needed
- reinstall gate and check gate alignment
